**DURABILITY OF
ASPHALT PAVEMENTS
FOR CALIFORNIA
GA-AIRPORTS,
PHASE ONE
(INSPECTION REPORT)**

**State of California
Department of Transportation
Sacramento, California 95814**

December 2006

**Final Report
Federal Report S/CA/AE-2006/33
Report No INE/AUTC 06.20**

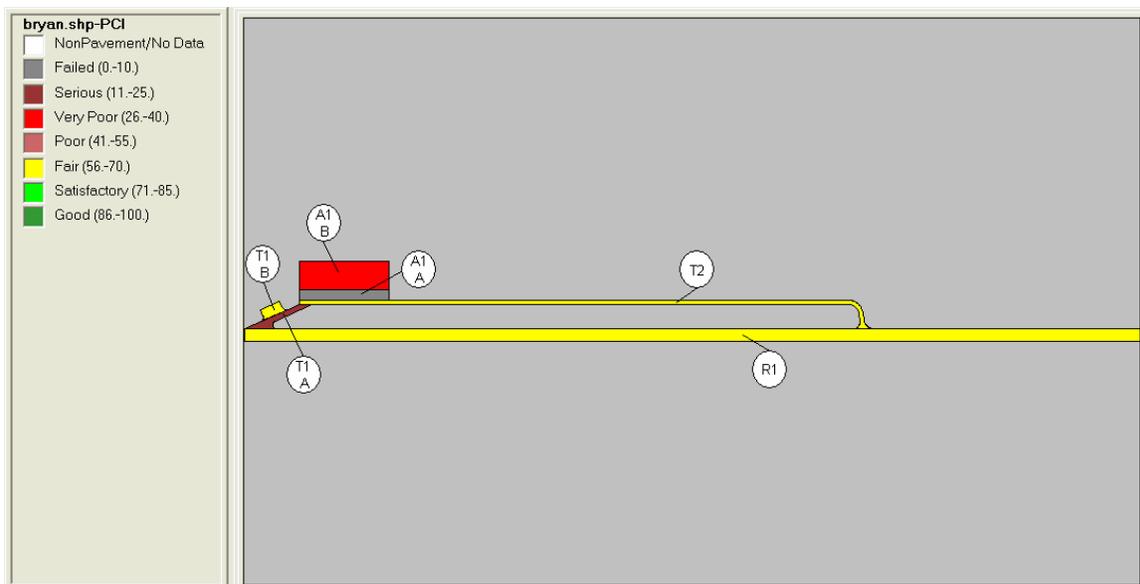
Figure 5. Bryant Airport Inspection Results

Runway 16/34 (R1) (PCI=69): Saw cuts were on a 25' by 25' pattern at the runway centerline, and on a 18' to 25' by 25' pattern along the pavement edge. At the runway's south end, there was extensive alligator cracking adjacent to the saw cuts, especially at the cut intersections. Longitudinal cracks existed at the construction joint at the runway centerline and other locations between transverse saw cuts. These longitudinal cracks were present for the majority of the runway, as were some transverse cracks between saw cuts. The runway exhibited signs of edge cracking on roughly 80% to 85% of its length.

Parallel Taxiway (T2) (PCI=69): The only signs of pavement distress were minor transverse cracks, spaced approximately 25 to 30 feet apart.

Apron (A1) (PCI=9 & 29 – before 2005 repaving): The apron was paved just prior to the field review.

Cross Taxiways (T1A & T1B) (PCI=24 & 69): Neither cross taxiway showed signs of distress, except at the construction joint where the taxiways met the runway.

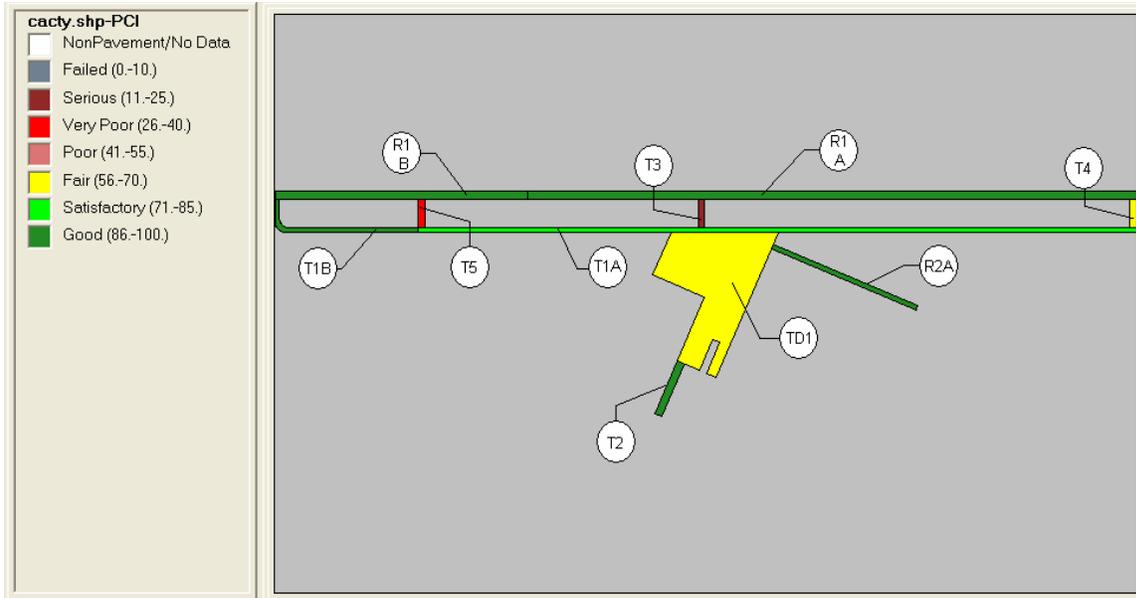
Figure 7. California City Airport Inspection Results

Runway 6/24 (R1Am R1B) (PCI=94, 93): Longitudinal cracks were present throughout the entire length of the runway. These narrow (<1/4" wide) cracks were located at the construction joints. In a few instances, the slurry seal had started to fail at the joints. Thirteen transverse cracks were present, but their spacing was inconsistent.

Parallel Taxiway (T1A, T1B) (PCI=74, 94): Starting on the west end and working east, the first section between cross T1B and T5, the second oldest pavement, showed signs of severe thermal cracking. The average crack spacing was 83.9 feet. The spacing of the thermal cracks on this section of the parallel taxiway was more consistent than the spacing of the thermal cracks on the runway. Cracks were previously sealed with a cold mix sealant, which created bumps. The oldest of the three pavements is on the east side between crosswinds T5 and T3 and after crosswind 3. This older pavement had severe block cracking. While some of this cracking was in a fairly tight grid pattern, other areas of block cracking appeared random and nonrectangular.

Cross Taxiways (T1B, T3, T4, and T5) (PCI=94, 22, 68, and 34): Cross T1B was paved with the same material as the taxiway and had experienced the same thermal cracking. These thermal cracks were also sealed with a cold mix as well and created similar bumps. T5 had signs of minor block cracking. T3 was repaved at the same time that the apron was reconstructed. The condition of cross taxiway T4 was the worst of the cross taxiways, showing both block and edge cracking; it was also the oldest mix.

Apron (TD1): The apron, which was repaved in 2005, showed no signs of pavement distress.

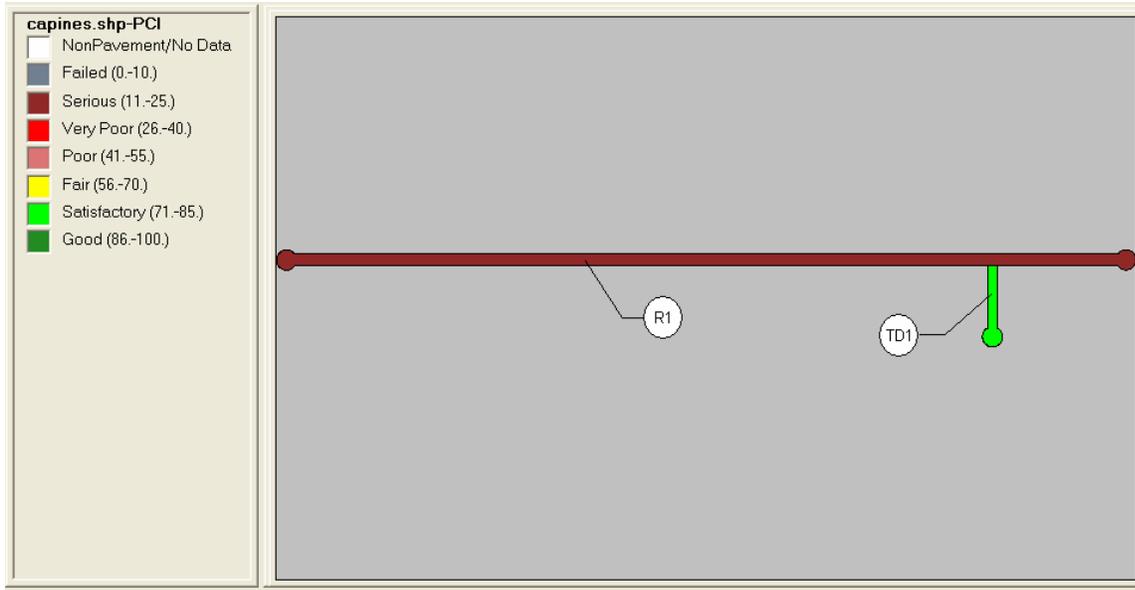
Figure 9. California Pines Airport Inspection Results

Runway 5/23 (R1) (PCI=18): The runway is severely cracked with block cracking over its entire length. Extensive alligator cracking is propagating from the longitudinal and transverse cracks; these cracks are up to 1 inch wide. Some of the cracks have been sealed.

Apron (TD1) (PCI=81): The apron was in better condition than the runway since it was recently overlaid in 1995. The taxiway had some wide (2.5" to 3") transverse cracks. The cracks were sealed, but they have since expanded beyond the sealant's capacity to maintain a seal. It does not appear that a backing rod was used prior to placing the crack sealant.

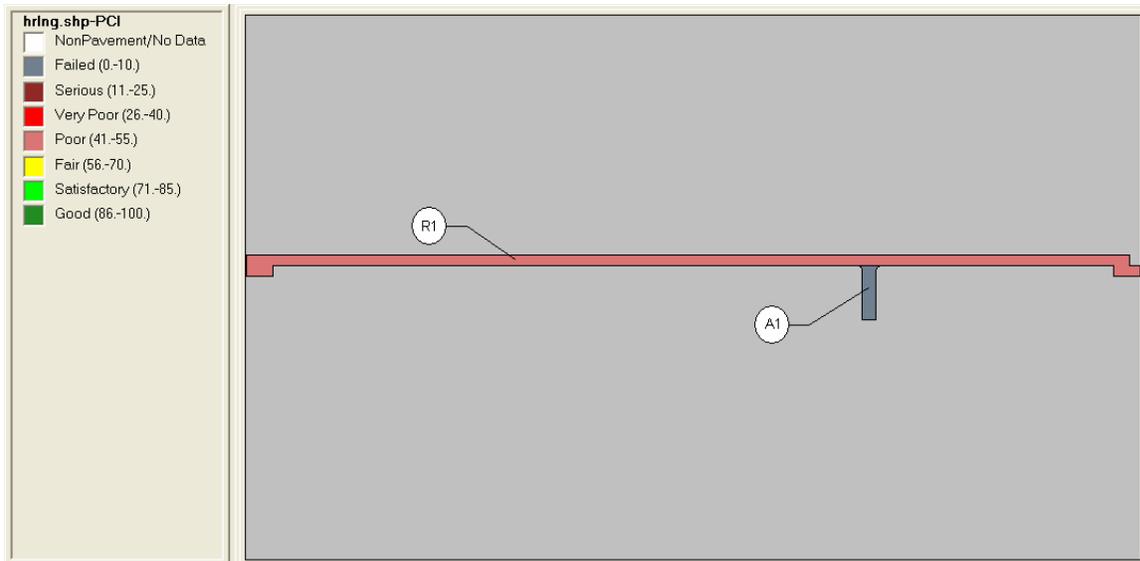
Figure 11. Herlong Airport Inspection Results

Runway 6/24 (R1) (PCI=54): The runway has extensive block cracking. It appeared that the runway underwent a sand slurry seal at some point in the past. At the time of this inspection, the sand slurry seal had shrinkage cracks and was not bonded to the pavement in numerous areas throughout the runway.

Apron (A1) (PCI=9): The apron has longitudinal and transverse cracking, but the majority of the pavement distress is due to alligator cracking, which was present on about 95% of the entire apron area.

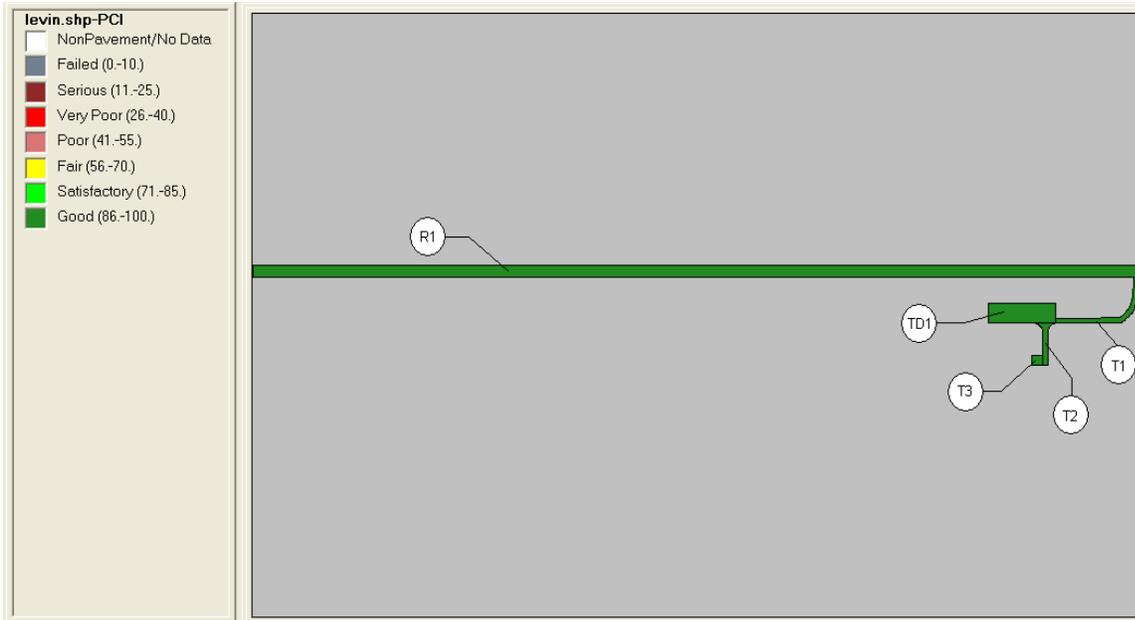
Figure 13. Lee Vining Airport Inspection Results

Runway 14/32 (R1) (PCI=100): The runway has some straight longitudinal cracking at the construction joints; the cracks were clean and less than half an inch wide. There was no sign of raveling or any other form of secondary distress associated with the longitudinal cracks. The runway also had some edge cracking, mainly present on the east side, for about 55% of its length. Transverse cracking was present in the south quarter of the runway; cracks varied in size from ½ to 1½ inches wide and 1 to 4½ inches deep. At some locations, the mat was segregated along a width of 12 inches along the construction joint.

Taxiway (T1, T2, and T3) (PCI=95, 100, and 100): There were isolated areas of segregation at the joints. In addition, there were areas with two linear bands of segregation running parallel to the paving panel; these bands were approximately 12 to 18 inches wide and they were separated by about 3 feet of non-segregated material. The taxiway also had some edge cracking on its inner radius, as the taxiway turned east, toward the runway.

Apron (TD1) (PCI=100): The apron also showed some segregation and signs of thermal cracking.

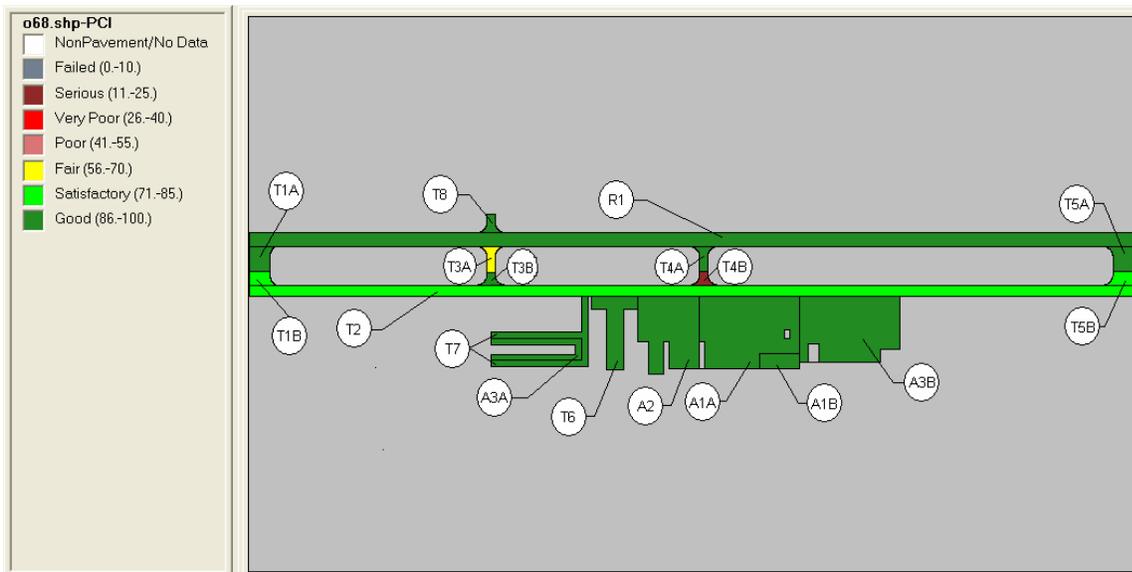
Figure 15. Mariposa-Yosemite Airport Inspection Results

Runway 8/26 (R1) (PCI=100): The runway has a longitudinal crack that runs along 80% to 85% of the construction joint at the runway centerline. The crack is narrow ($< 1/4''$) wide. An additional longitudinal crack runs to the left of the centerline joint; this could be a

reflective crack from the original pavement, when the runway was only 50 feet wide. A large amount of checking was evident, along with a few minor patches of apparent segregation along the edge of the paving panel.

Parallel Taxiway (T2) (PCI=79): Block cracking was present on the south end of the parallel taxiway (T/W). The north end showed transverse cracks which were randomly spaced; occasionally a longitudinal crack existed at the centerline construction joint.

Cross Taxiways (T1 A, T1 B, T3 A, T3 B, T4 A, T4 B, T5 A, and T5 B) (PCI= 100, 73, 69, 90, 96, 20, 100, and 72): All cross T/Ws showed block cracking; the T/Ws were crack-sealed and covered with a slurry seal in 1997. There was also a transverse crack at the construction joints between the new and old pavement. Edge cracking was also present at some of the edges of the cross T/Ws.

Parking Apron (A1 A, A1 B, and A3) (PCI= 89, 98, and 100): The south end of the parking apron had been coated with coal tar to protect the pavement surface from fuel spills.

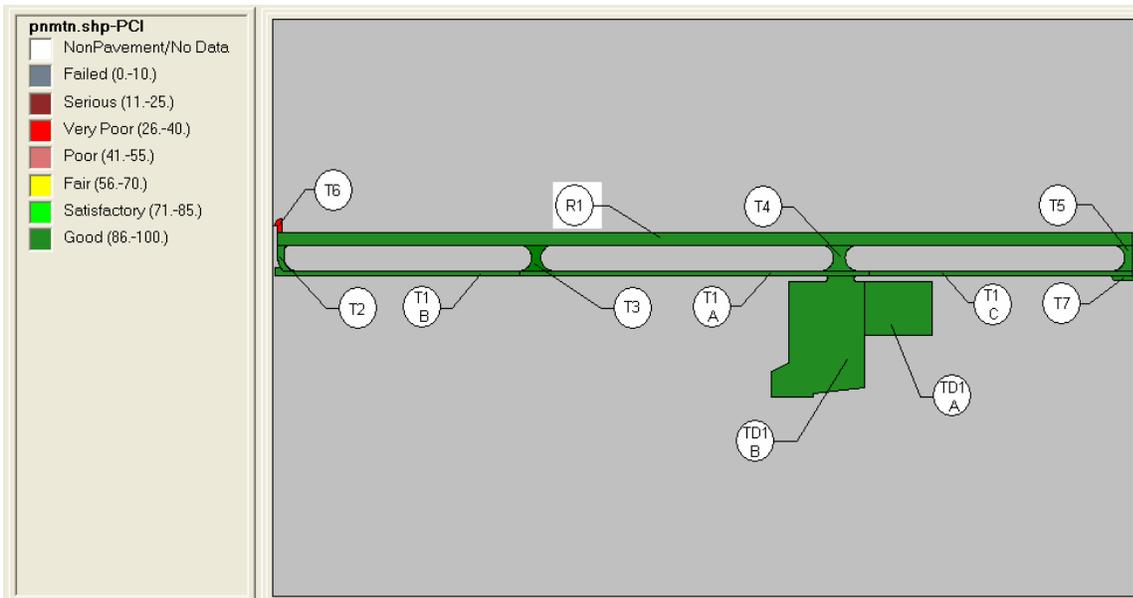
Figure 17. Pine Mountain Lake Airport Inspection Results

Parallel Taxiway (T1- A, B, C) (PCI=94, 100, and 100): There was some minor longitudinal cracking at the joint between the taxiway and the preflight apron on the east end. There was extensive transverse cracking in a 1,200 foot long section in T1-A. Average spacing between transverse cracks was 42 feet.

Apron (TD1 – A &B) (87,100): No cracks were evident in the pavement in the west section (TD1 B). The east section (TD1 A) has some block cracking and thermal cracking at the tie down areas. The tie down areas also appeared to be sealed with coal tar to protect the pavement from fuel spills.

Cross Taxiways (T2, T3, T4, and T5) (PCI=100, 95, and 90,100): The cross taxiways were in good condition, with only a few random cracks and one crack forming above a culvert.

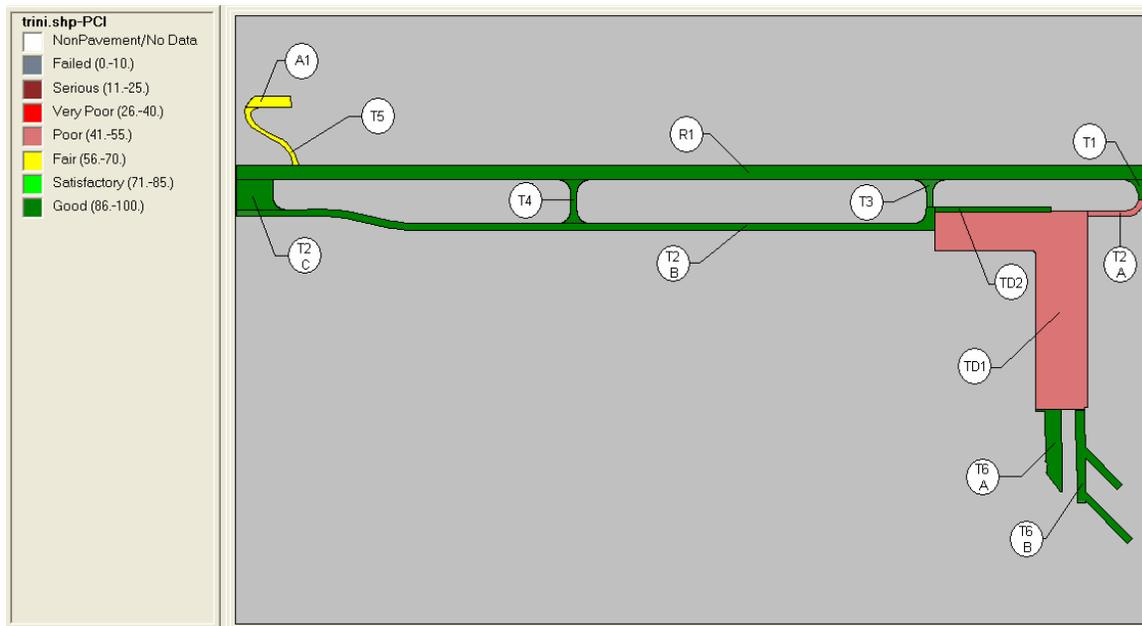
Figure 21. Trinity Center Airport Inspection Results

Parking Apron TD1 (PCI 49): The parking apron had extensive transverse and longitudinal cracking. The majority of the longitudinal cracking was located at the construction joints. Alligator cracking was also present in some low spots where water will accumulate. This parking apron was slurry-sealed in 2004, but the underlying cracks reflected through the seal.

Parallel Taxiway T2B (PCI 96): The parallel taxiway area was in good condition; the only sign of distress was a longitudinal crack down the middle of the taxiway at the construction joint. The crack was discontinuous along the length of the taxiway, but did extend roughly 40% to 50% of the length. The crack was clean with no raveling or deterioration.

T/Ws T3 and T4 in between. Cross T1 had experienced some transverse cracking and fatigue cracking at the edges. Cross T3 and T4 both had transverse cracking located at the center of each, at the low point for drainage. These two cross taxiways both showed cracking along the construction joints. At the northern cross (T2C), early stages of block cracking were present.

Runway R1 (PCI 87): The runway has longitudinal cracks along a majority of the construction joints. The cracks were narrow (< 1/2" wide), clean, and showed no sign of additional pavement distress.
