Wearing Surface Testing and Screening: Yukon River Bridge

INTERM FINAL REPORT

AUTC Report # 410008
DTRT06-G-0011
T2-10-07

April 2012

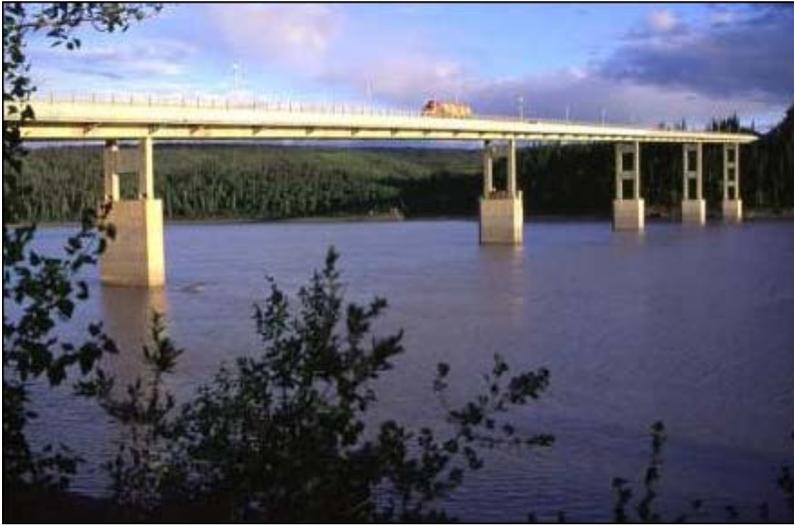
Figure 1. Yukon River Bridge 1

The Yukon River Bridge is a two lane highway bridge with an orthotropic steel deck structure located about 50 miles North of Fairbanks on the Dalton Highway. The bridge was designed to carry highway traffic and the oil pipeline across the Yukon River. When it was built in the early 1970's, a two layer temporary timber wearing surface was installed over the steel deck. Because the bridge is on a 6% grade, trucks typically use tire chains to provide traction. The chains tend to cause serious wear on the timber surface over time. Due to the severe climate changes and intense loading from passing trucks, the timber surface deteriorates at a rapid rate.

Over a thirty year period, the timber surface was replaced in 1981, 1992, 1999 and 2007. As the quality of the timber wood decreased, the time between replacements also decreased which resulted in an increase in material costs. Therefore the Alaska Department of Transportation became interested in finding an alternative wearing surface that provide longer life, be relatively lightweight, offer flexible and improve traction. The alternative wearing surface must also be easy to install and maintain, and overall be a more economic option compared to timber.

The Yukon River Bridge wearing surface has two layers of 63 mm wood planking on top of an orthotropic steel deck. The bottom layer of the planks is bolted to the steel deck and the top layer is lag bolted to the layer underneath. This wood wearing surface has been used by the AKDOT since the bridge was constructed in 1976. Depending on the age of the timber, the top layer deteriorates rapidly due to a combination of decay, traffic and tire chain damage. Not only must an alternative wearing surface provide longer life under these conditions, but must also accommodate the 6% grade by providing traction for heavy trucks. The alternative wearing surface must also be relatively lightweight, provide flexibility for the bridge and require a more economic operation.

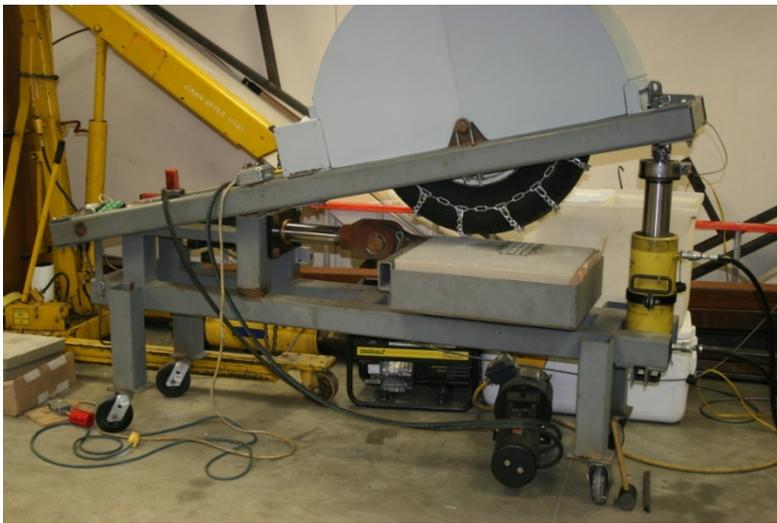
Figure 2. Test Equipment 1

Since there was no known laboratory test equipment found to determine wear due to tire chains, an apparatus was developed by Wilhelm. This testing apparatus consists of a lower and upper steel frame with a 14 ply 235/85R16 tire attached to the upper frame and spins on an axle. A tray is placed underneath the tire on the lower frame which is attached to a hydraulic ram that pushes and pulls the tray back and forth over a distance of 20 cm. The upper steel frame is attached to another hydraulic ram which elevates one end of the upper frame on a pivot. This in turn raises or lowers the tire onto the tray which contains a wearing surface panel that is to be tested. Electric load cells are attached to each hydraulic ram to measure the vertical and horizontal force on the tire as the tray moves in a direction. These readings are recorded by a data collector which is then displayed on a nearby laptop. The laptop uses proprietary software designed to work with the data collector to allow for calibration and corrected readings. The apparatus is approximately 60 cm wide and 230 cm long with a weight of around 4500 N. For test samples to fit in the tray, they must have dimensions of 45 cm wide by 61 cm long by 15 cm thick.

Since it is impossible to conduct a test that covers all of these factors, each factor is tested and analyzed separately. To test for traction, the tire is loaded onto the sample panel in the tray with a force of 4500 N (which was determined as an average value for the weight of trucks that pass over the Yukon River Bridge). With the tire locked at its axle, the hydraulic ram moves the tray back and forth, resulting in traction between the tire and the sample panel. The horizontal forces caused by the traction are measured by the load cell attached to the hydraulic ram. These measurements are then recorded by the data collector and are used to approximate a value for the coefficient of friction that the sample panel offers. This value is taken after the tray has moved back and forth for five to six cycles, which gives a more accurate approximation for what traction the alternative wearing surface has to offer after long term wearing.

To test for wear that is caused by dragging chains over the alternative wearing surface, the tire is locked at its axle with the tray moving back and forth. However, tire chains are attached as tight as possible to the tire. Instead of finding the coefficient of friction, the displacement in the surface of the sample panel caused by the tire chains is measured. This is done by using a profiler before the chain dragging test to measure the relative heights of the surface, then measuring the displacements in the surface after the test using the same profiler.

Tire chains that roll over a surface can cause punctures in small areas. These tiny displacements can be measured by unlocking the tire from its axle and moving the tray back and forth with the sample panel. A pre-profile is required before the rolling test is performed. To account for loose chains that lash against the surface, the apparatus is modified such that an edge of the sample panel is exposed to the lashing tire chains. With the top steel frame unattached from the hydraulic ram, the top frame is lifted and lowered by an attached lever that is controlled manually by the operator. A motor spins the tire up to 45 miles per hour (which was determined as an average speed for trucks to pass over the Yukon River Bridge), which causes the loose tire chains to lash against the sample panel. This is done for two seconds which simulates long term wear. Once again, a pre-profile is required before the test in order to measure the displacement in the surface.
