AUTC Pavement/Asphalt Research Projects Update

June 20, 2012

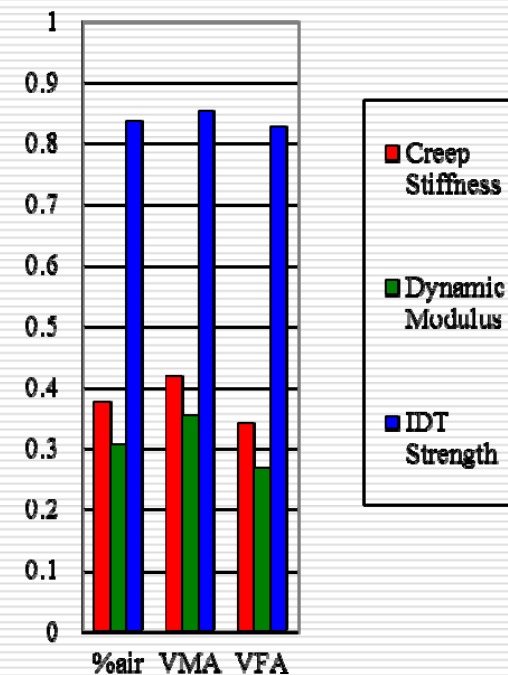
Correlation between volumetric and mechanical properties

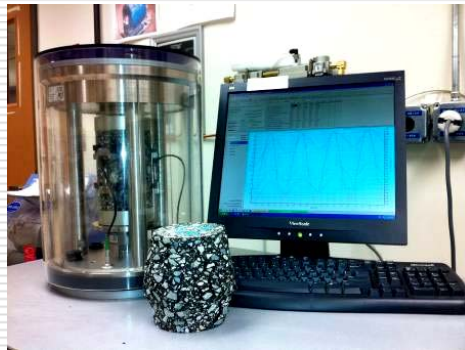
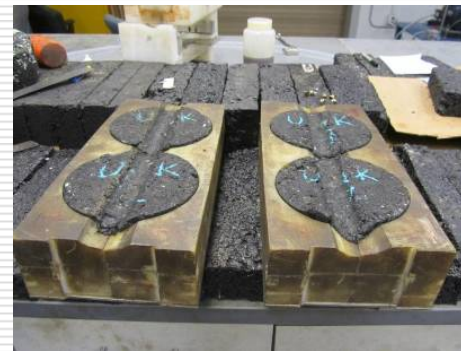
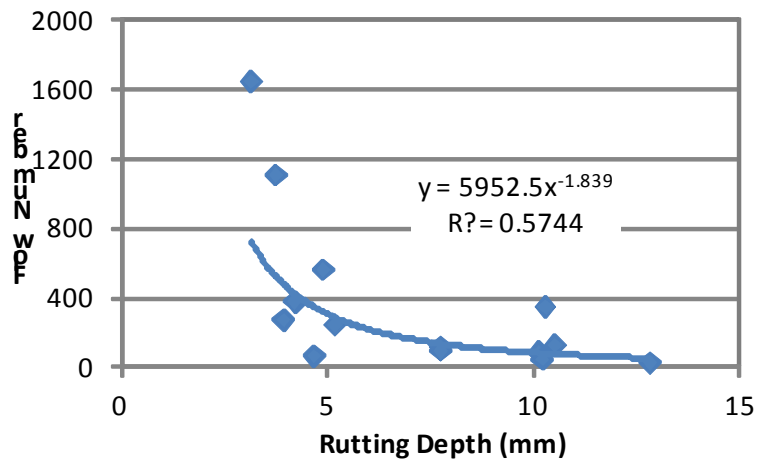
Correlation

- Verify $|E^*|$
 - Witczack model (2002)
 - Modified Witczack model (2006)
 - Hirsch model (2003)
 - Al-Khateeb model (2006)
- Correlations
 - APA & F_t (F_n)
 - APA & $|E^*|$ ($|E^*| / \sin\phi$)
- Draft Report

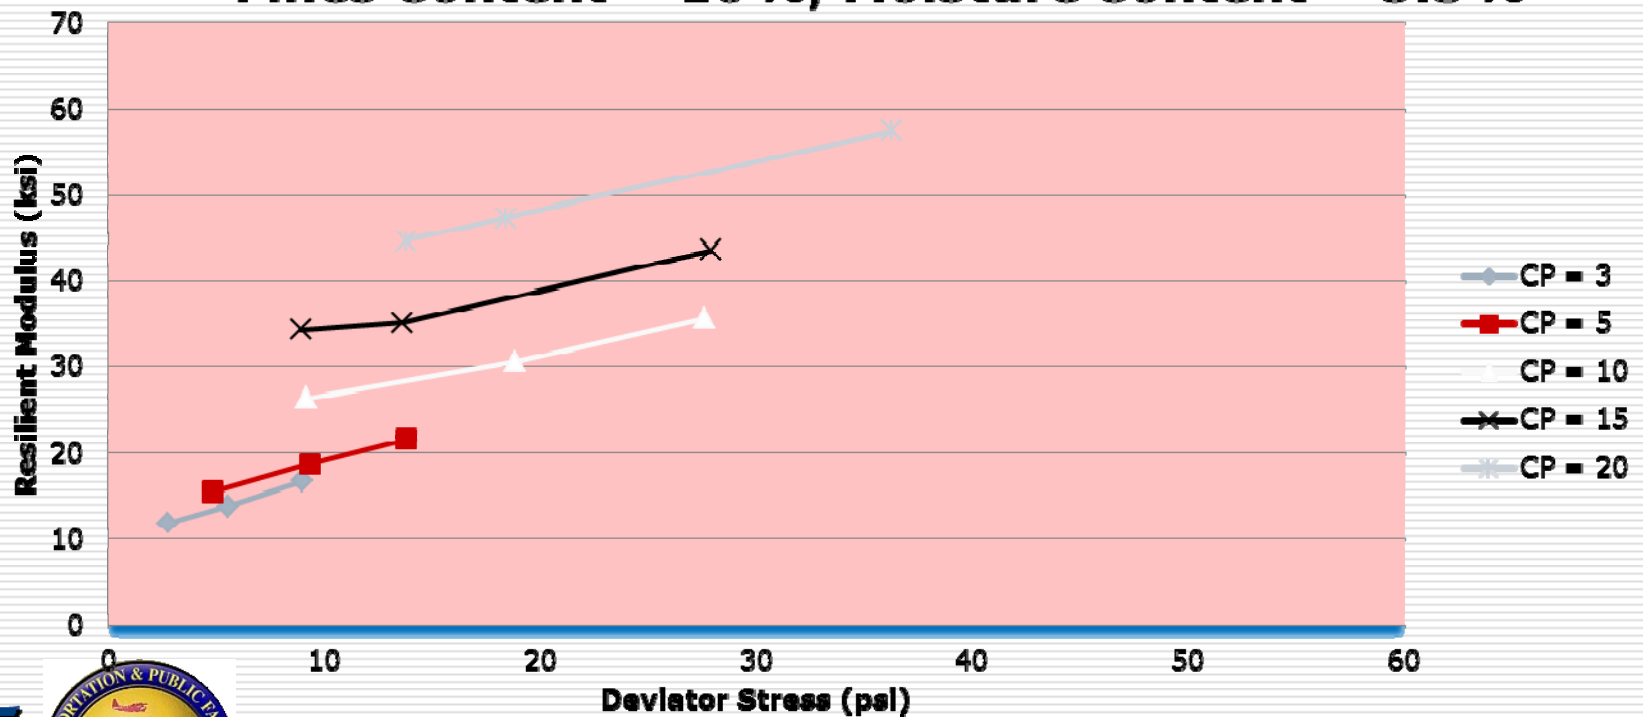
Resilient Modulus @ 20° C
Fines Content = 10%, Moisture Content = 5.3%
