**DURABILITY OF
ASPHALT PAVEMENTS
FOR CALIFORNIA
GA-AIRPORTS,
PHASE ONE
(INSPECTION REPORT)**

**State of California
Department of Transportation
Sacramento, California 95814**

December 2006

**Final Report
Federal Report S/CA/AE-2006/33
Report No INE/AUTC 06.20**

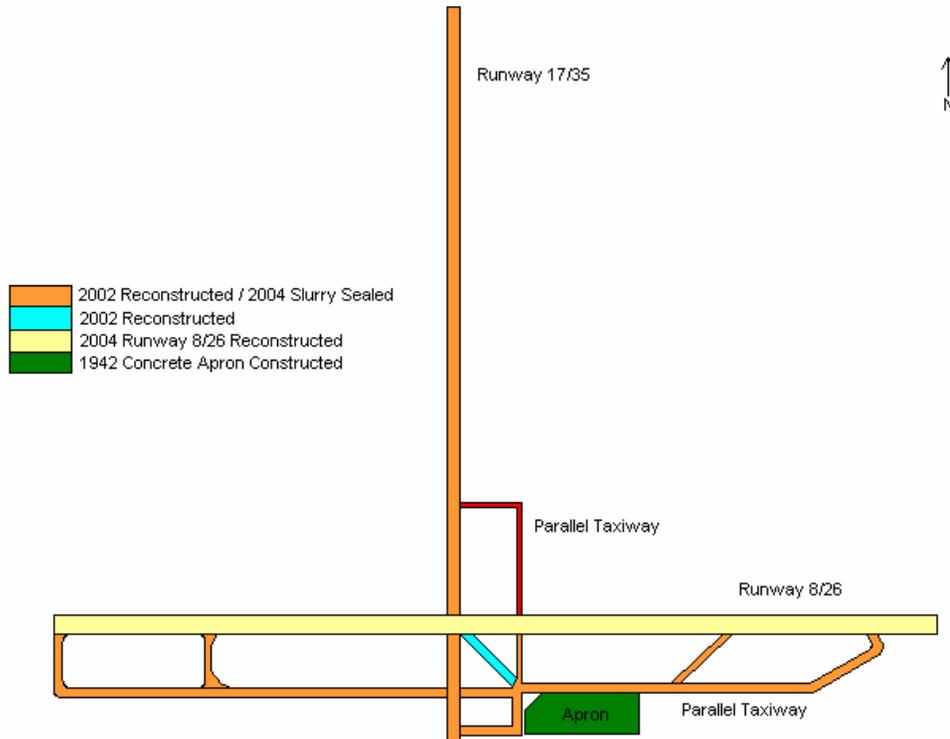
Figure 2. Blythe Airport Construction History

Parallel taxiway for runway 8/26 (T5): The taxiway showed signs of block cracking with transverse cracking spaced every 25 feet and longitudinal cracking every 12.5 feet. The longitudinal cracks corresponded with the construction joints.

Runway 8/26 (R2A, R2B, R2C) (Reconstructed post APMS study): Minor longitudinal cracks and transverse cracks were present. The runway was constructed in panels 15 feet wide, and longitudinal cracks were present at the joints of the pavement panels. Transverse cracks were present only on the east end of the runway; the rest of the runway appeared free of them.

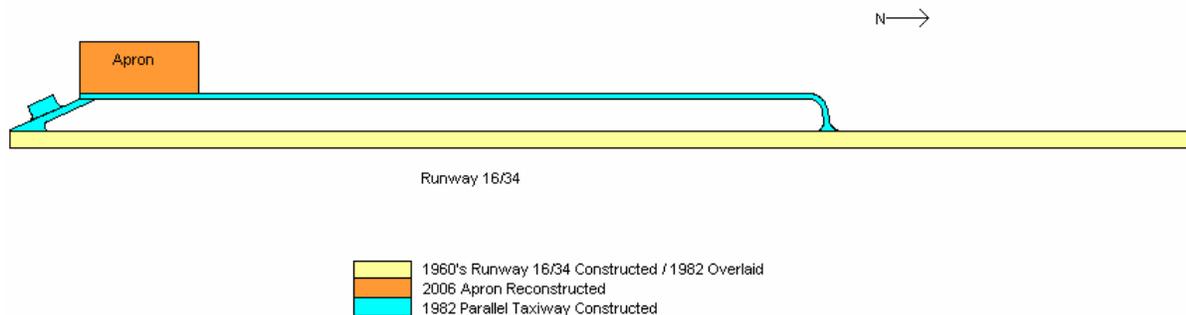
Figure 4. Bryant Airport Construction History

Parallel Taxiway (T2) (PCI=69): The only signs of pavement distress were minor transverse cracks, spaced approximately 25 to 30 feet apart.
